SSC-408

DETECTION PROBABILITY ASSESSMENT OF VISUAL INSPECTION OF SHIPS

SHIP STRUCTURE COMMITTEE 1999

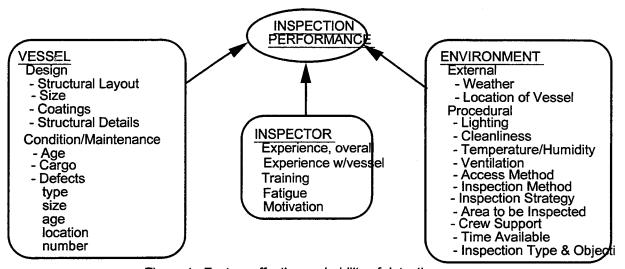
Figure 1. Factors affecting probability of detection.

In a previous project, a preliminary model of the factors affecting POD in tanker inspection was developed, and is shown in Figure 1. Reviews of literature and interviews with inspectors indicated that the factors associated with an inspector, in particular, experience, would likely be important determinants of POD, along with factors such as access and lighting. Several approaches for evaluating POD were identified, with benchmarked inspection data (a comparison of two inspections of the same structure that take place within a relatively short time) and in situ experiments (a comparison of the performance of multiple inspectors inspecting the same structure under controlled conditions) considered to be the most promising. An application of the benchmarked inspection data approach to historical survey data for two ships highlighted the importance of several factors: prior knowledge of the history of a particular vessel and sister ships, the purpose of the inspection, and factors such as lighting, access, and cleanliness that may be different for different tanks on the same ship. The POD factor model and selected data from the benchmarked inspection case study can be found in [Demsetz et al. 1996b]. The full literature review, model development, and case study results can be found in [Demsetz et al. 1996a]

One factor that may affect inspection rate is the amount of time available for an inspection (procedural environment factor in Figure 1). Inspectors 2 and 6 measured each marker that they found. It is estimated that this added roughly 10 seconds to the time required to record each marker that these inspectors detected, as compared with the time required by other inspectors. Thus, in evaluating the effect of time in tank, an "adjusted time in tank" is used for inspectors 2 and 6. The adjusted time is the observed time less 10 seconds for each marker found.

The inspector factors shown in Figure 1 include factors related to experience (overall experience, experience with the particular vessel, training) and factors related to the inspector's current situation (fatigue and motivation). Questionnaire responses allow an investigation of the effect of the experience factors, and, to a lesser extent, the effect of fatigue. The only information regarding the motivation of the inspectors is through the researchers' casual observations.

Of the environment factors shown in Figure 1, only inspection strategy and time available varied among inspectors in this experiment. There is no objective information available on inspection strategy. However, Inspector 3, who had no prior tank inspection experience, was observed to work very carefully and methodically through Tank 5P, while the other inspectors initially carried out a broader scan of a particular area, then focused on critical areas. This "scan/focus" strategy appeared to change for at least some inspectors as they made their way through the tank and found markers in non-critical areas. Inspector 6 reported switching to an "Easter egg hunt" strategy; looking at all areas, rather than carrying out a broad scan and then focusing on critical areas.

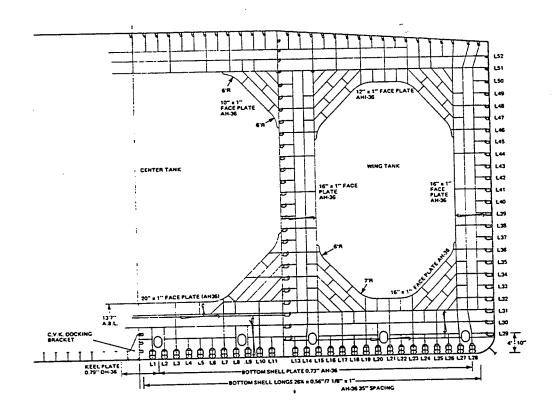
Figure 2. General Arrangement and Typical Midsection, Ship One.

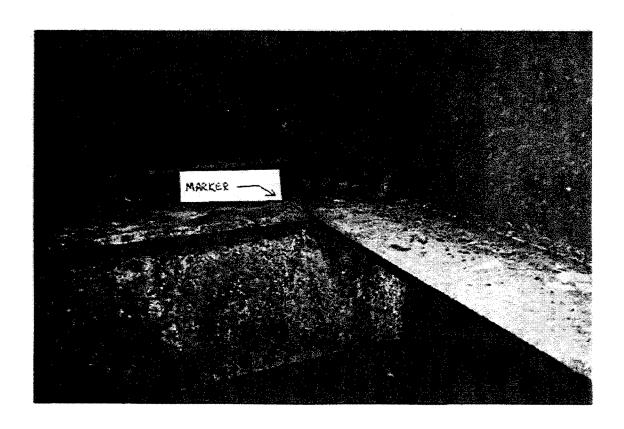
Figure 3. Typical Markers, Ship One.

In Tank 5P, markers were used to simulate cracks. The intent was that the markers be roughly as easy or hard to detect as cracks, not that they necessarily look like cracks. An additional objective was that a marker, once detected, could be easily identifiable by an inspector as indeed being a marker. Lead pencils, grease pencils of various colors, and brown and black architectural drafting tape in 1/8 and 1/16-inch widths were tried on various locations within Tank 5P. A lead pencil line most closely resembled a crack. However, in locations with waxy buildup, it was difficult to mark with the pencil without significantly disturbing the surface. Furthermore, in some locations it was difficult to determine whether the pencil mark was indeed a pencil mark or was just a shadow. Of the other marker options, the black architect's tape most closely satisfied the detectability criterion; in many different locations, it was roughly as easy to detect as a crack. Once seen, the black tape was clearly identifiable as a marker; inspectors would not confuse it with any other feature in the tank. Although the black tape did not stick well in a few locations where there was dusty or dried residue, in most locations it adhered well to the tank structure and any residue present. Therefore, black architect's tape was selected as the marker material. Figure 3 shows typical markers.

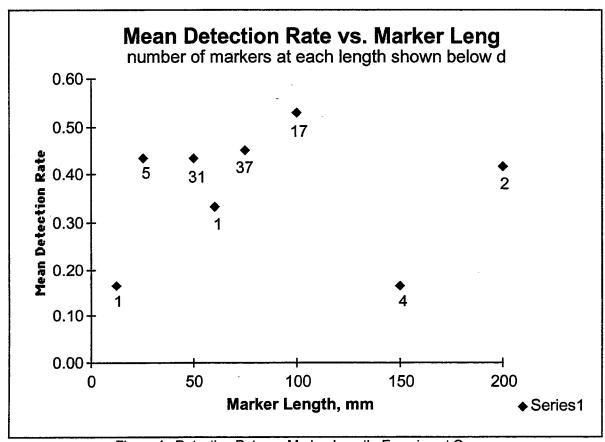
Figure 4. Detection Rate vs. Marker Length, Experiment One

Of the vessel factors shown in Figure 1, only the defect factors vary in this experiment. Defect size, location, and number can be compared with detection rate. Table 4 and Figure 4 shows the detection rate as a function of marker length. The number of markers at each length is also shown. Where there are 17 or more markers at a particular length, the mean detection rate ranges from 0.44 to 0.53.

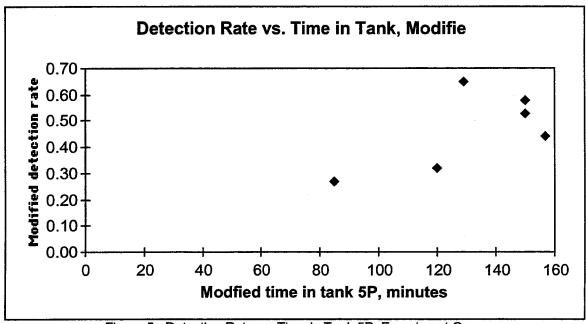
Figure 5. Detection Rate vs. Time in Tank 5P, Experiment One.

Table 7 shows the time each inspector took in Tank 5P along with detect rate. Figure 5 shows this same information graphically. The two inspectors who spent the least time in Tank 5P also had the lowest detection rates. However, there is no clear relationship between time in tank and detection rate for the other inspectors.

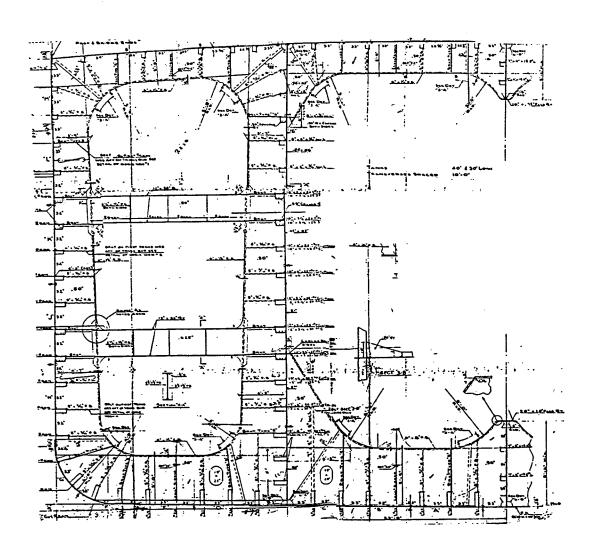
Figure 6. General Arrangement and Typical Midsection, Ship Two.

Experiment Two was carried out on Ship Two, a 32,650 ton deadweight oil tanker. At the time of the experiment, Ship Two was docked in Port Arthur, Texas. While other work was being done in anticipation of the replacement of the ship's forebody, the owner allowed access to the existing forebody for the inspection experiment. The existing forebody was to be scrapped, and the owner anticipated that it would contain many cracks. Figure 6 shows the general arrangement and typical midship section of Ship Two. In the side tanks, bottom longitudinal #20 (the center of the tank) had been built up; in the center tanks, bottom longitudinal #28 had been built up on each side of the center line.

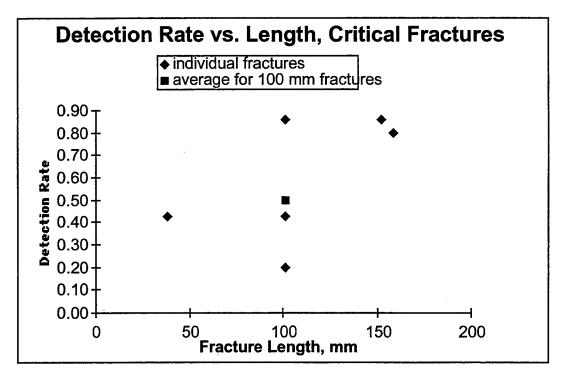
Figure 8. Detection Rate vs. Fracture Length, Experiment Two.

Of the eight visible fractures, six were considered to be critical by at least one reviewer. Only these six fractures are included in the quantitative analysis. Detection rates for these fractures ranged from 0.20 (one of five inspectors) to 0.86 (six of seven inspectors). Figure 8 shows detection rate vs. length for the six fractures considered critical. In general, there is an increase in detection rate with length. This is clear when the mean detection rate for the four inch fractures is considered. The overall detection rate for these fractures (that is, the average of the detection rate for each individual fractures) was 0.60. The average detection rate for the two non-critical fractures was 0.29.

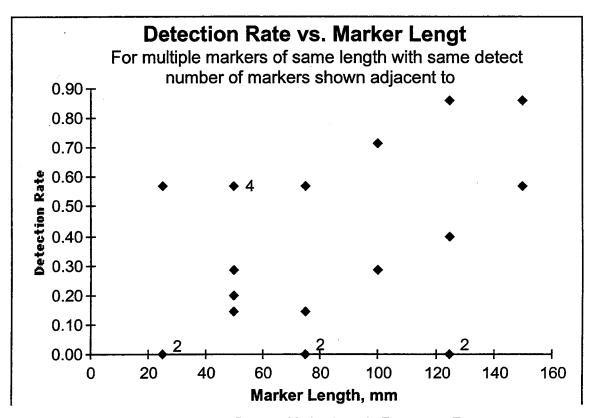
Figure 9. Detection Rate vs. Marker Length, Experiment Two

The locations of all 22 markers were considered to be critical by at least one reviewer. As noted above, marker detection rates ranged from 0.00 to 0.86. Figure 9 shows detection rate vs. length for the markers. In general, there is an increase in detection rate with length. This is more clearly shown in Figure 10, where the mean detection rate for each marker length is plotted. However, a linear regression on the marker data shows only a slight correlation ($R^2 = 0.094$), due to the broad range of observed detection rates within each marker length. Figure 11 shows mean marker and critical fracture detection rates; for this experiment, markers appear to yield detection rates that are comparable to or slightly lower than those of critical fractures. Table 11 shows fracture and marker detection rates by length for each inspector.

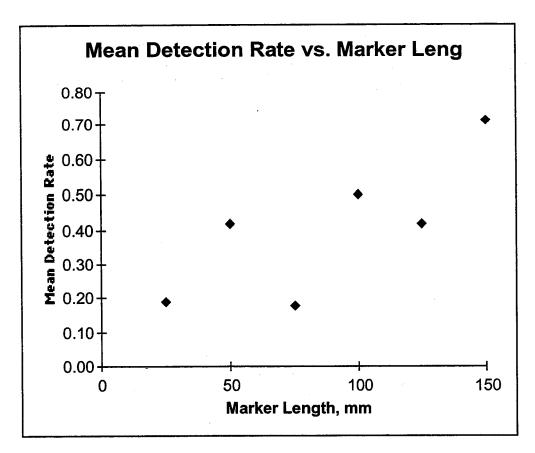
Figure 10: Mean Detection Rates vs. Marker Length, Experiment Two

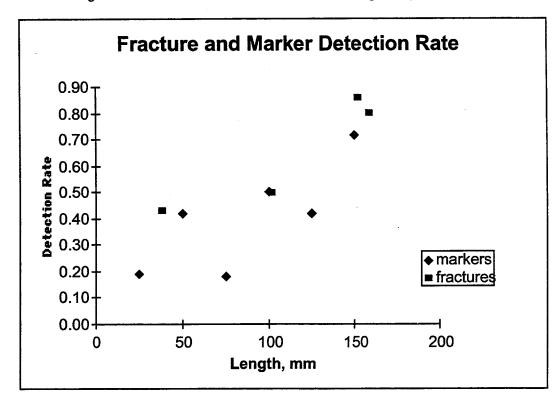
Figure 11. Detection Rates for Fractures and Markers, Experiment Two.

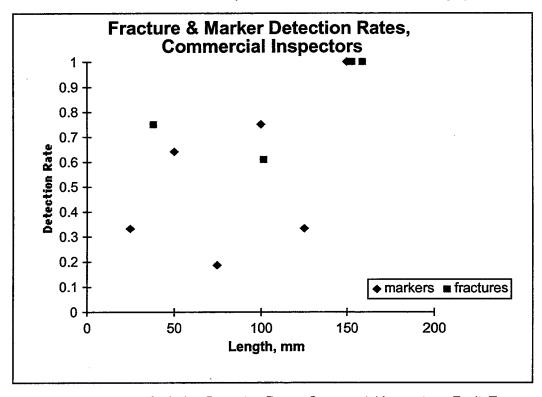
Figure 12. Fracture & Marker Detection Rates, Commercial Inspectors, Exp't. Two.

Commercial inspectors are typically the "front line" in inspection, hired by owners and operators to identify problem areas and critical fracture characteristics and number. For many purposes, commercial inspectors' performance is the most relevant measure of probability of detection. The fracture and marker detection rates of commercial inspectors are shown in Figure 12. For the limited data generated by this experiment, the two fractures and two markers with length of approximately 150 mm were detected by all four commercial inspectors. For shorter fractures and markers, detection rates were lower. Average detection rates for markers ranged from 0.19 (for four markers of 75 mm in length) to 0.75 (for two markers of 100 mm in length). The lowest observed fracture detection rate was 0.61 (for three fractures of 100 mm in length).
